# Test report

Clickfit EVO fastening system

**0131-L-18/3**

determination of mechanical resistance  
(compressive strength)

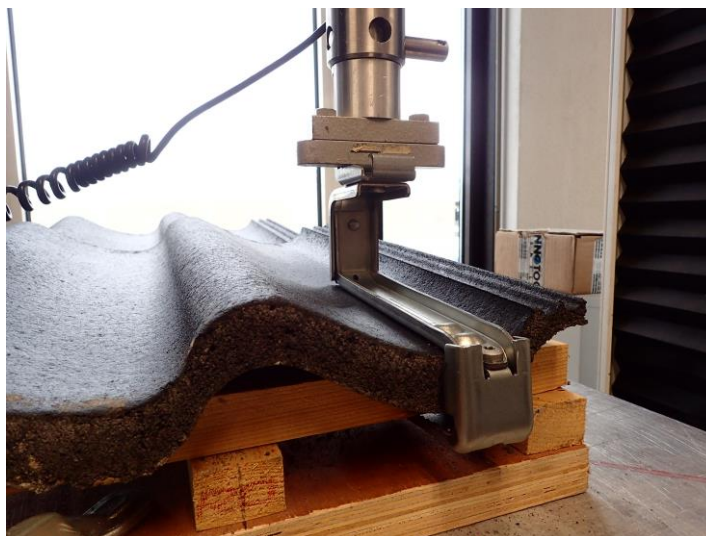
**Photo 1**  
Overview of the test on  
Sneldek Novo+ (new),  
left valley.

### 2.2 Test 131/3 A1 (ClickFit EVO and Sneldek Novo+ (new)) left valley

- Substructure : The tile battens, dimensions 25 mm × 38 mm have been placed with a centre to centre spacing of 345 mm and have been fastened to the wooden substructure.
- Tiles : on top of the battens two tiles type Sneldek Novo+ have been placed.
- Roof hook : on the upper tile one ClickFit EVO roof hook universal have been positioned in the left valley.

Test specimen	Axial load [N]		
	Sneldek Novo+		OVH 206
	left valley	right valley	
1	1038	1424	1509
2	1019	1336	1211
3	1082	1316	1176
4	1115	1405	1360
5	1014	1375	1311
6	1030	1389	1464
7	1069	1448	1316
8	939	1519	1427
9	1061	1409	1302
10	1022	1563	1156
<b>Mean value (m)</b>	<b>1039</b>	<b>1418</b>	<b>1323</b>

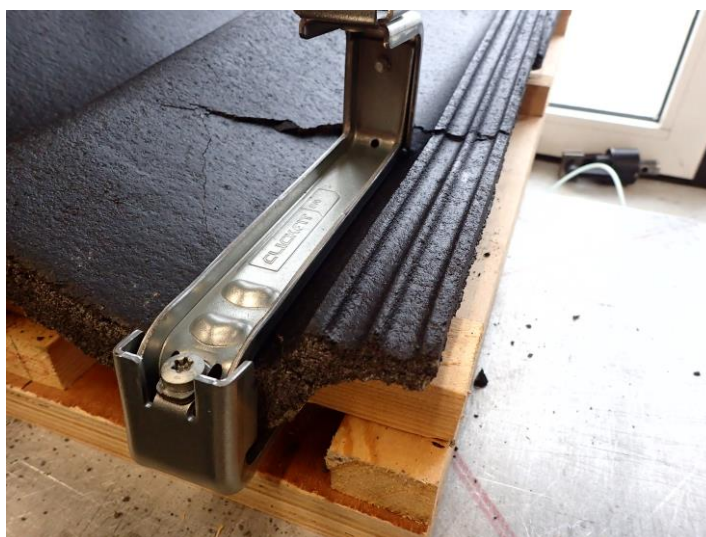
**Photo 2**  
detail of the collapse  
image.

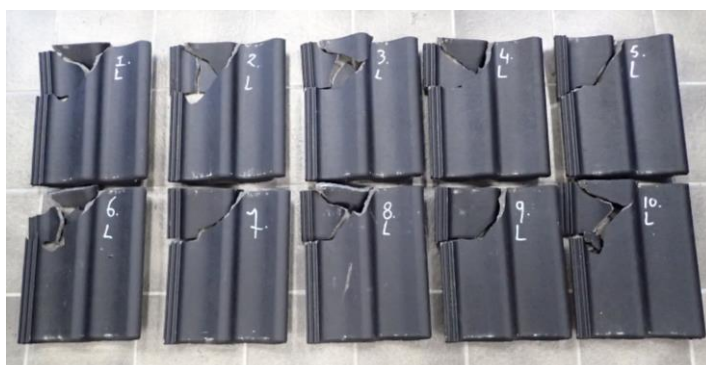
**Photo 3**  
Overview of the collapse  
images.

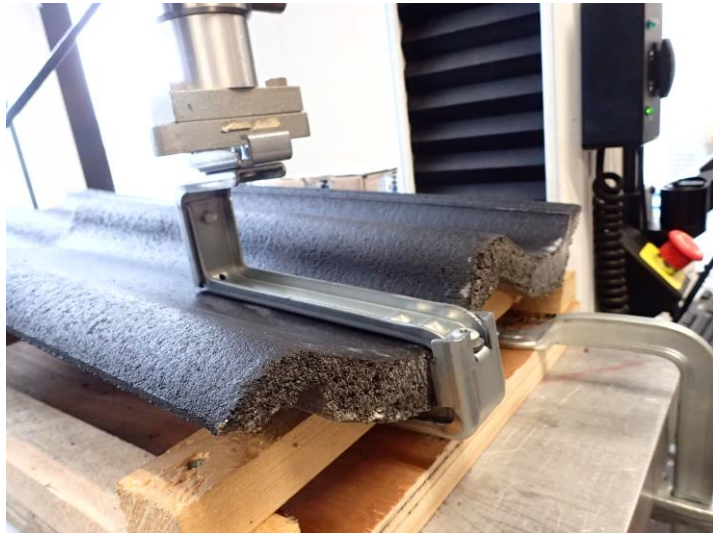
**Photo 4**  
Overview of the test on  
Sneldek Novo+ (new),  
right valley.

### 2.3 Test 131/3 A2 (ClickFit EVO and Sneldek Novo+ (new)) right valley

- Substructure : The tile battens, dimensions 25 mm × 38 mm have been placed with a centre to centre spacing of 345 mm and have been fastened to the wooden substructure.
- Tiles : on top of the battens two tiles type Sneldek Novo+ have been placed.
- Roof hook : on the upper tile one ClickFit EVO roof hook universal have been positioned in the right valley.

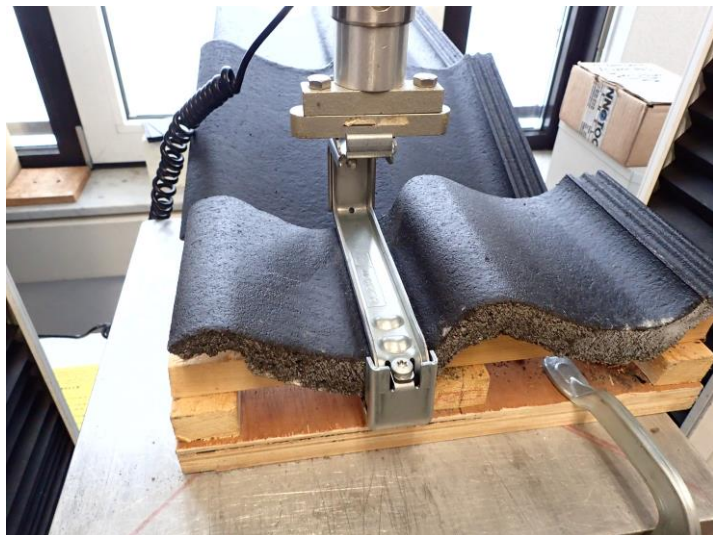
**Photo 5**  
Detail of the collapse  
image.

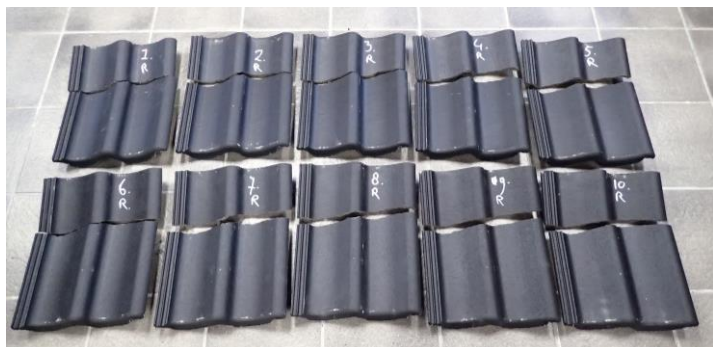
**Photo 6**  
Overview of the collapse  
images.

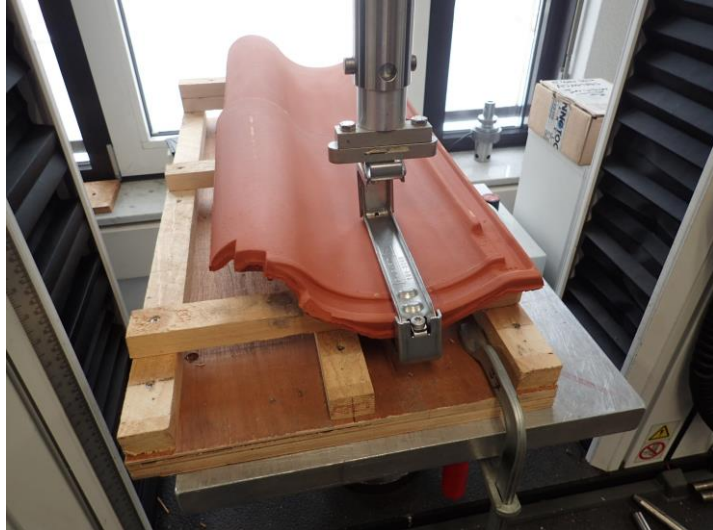
**Photo 7**  
Overview of the test on  
OVH 206 (new).

### 2.4 Test 131/3 B (ClickFit EVO and OVH 206 (new))

- Substructure : The tile battens, dimensions 25 mm × 38 mm have been placed with a centre to centre spacing of 315 mm and have been fastened to the wooden substructure.
- Tiles : on top of the battens two tiles type OVH 206 have been placed.
- Roof hook : on the upper tile one ClickFit EVO roof hook universal have been positioned in the valley.

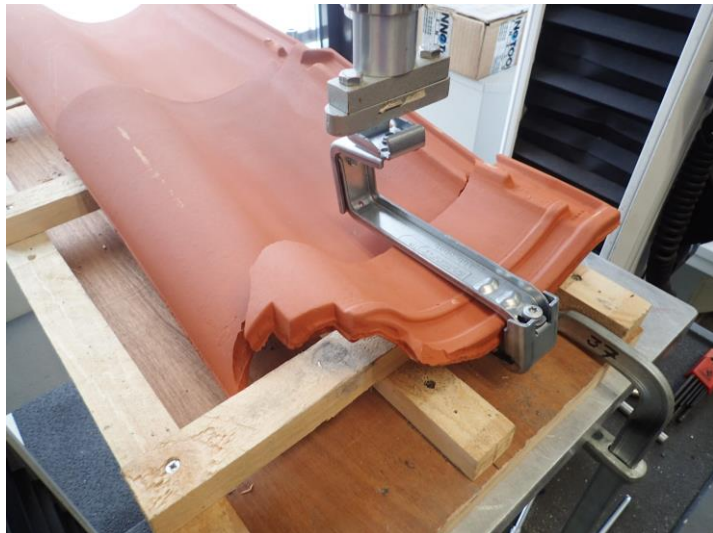
**Photo 8**  
Detail of the collapse  
image.

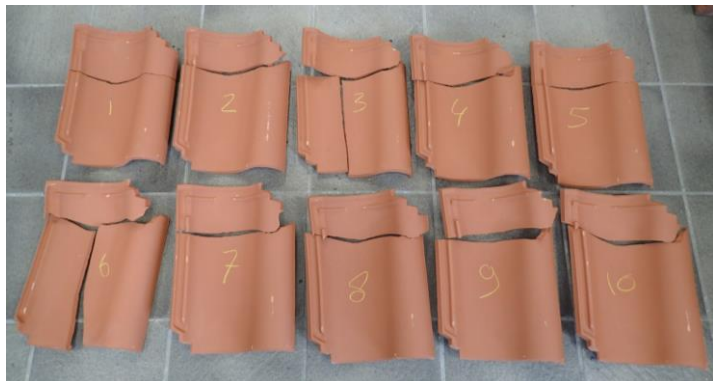
**Photo 9**  
Overview of the collapse  
images.

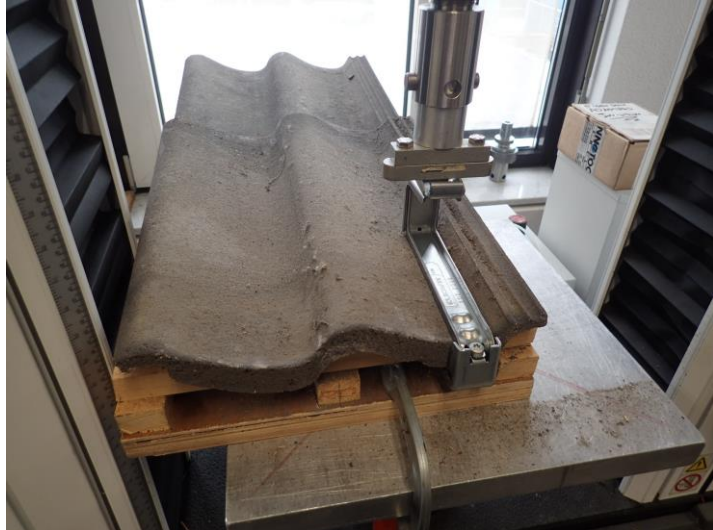
**Photo 10**  
Overview of the test on  
Sneldek RBB (used),  
left valley.

## 2.5 Test 131/3 C1 (ClickFit EVO and Sneldek RBB (used)) left valley

- Substructure : The tile battens, dimensions 25 mm × 38 mm have been placed with a centre to centre spacing of 345 mm and have been fastened to the wooden substructure.
- Tiles : on top of the battens two tiles type Sneldek RBB have been placed.
- Roof hook : on the upper tile one ClickFit EVO roof hook universal have been positioned in the left valley.
-

Test specimen	Axial load [N]			
	Sneldek RBB		OVH	VH-V
	left valley	right valley		
1	1509	2088	1528	2141
2	1493	2081	1711	1735
3	2101	2139	1318	2018
4	1729	2463	1522	2141
5	1618	1938	1280	1403
6	1752	1981	1634	1537
7	1528	1881	1556	1678
8	1716	2006	1336	1926
9	1703	1882	1414	1231
10	1533	2171	1326	1628
<b>Mean value (m)</b>	<b>1668</b>	<b>2063</b>	<b>1462</b>	<b>1744</b>

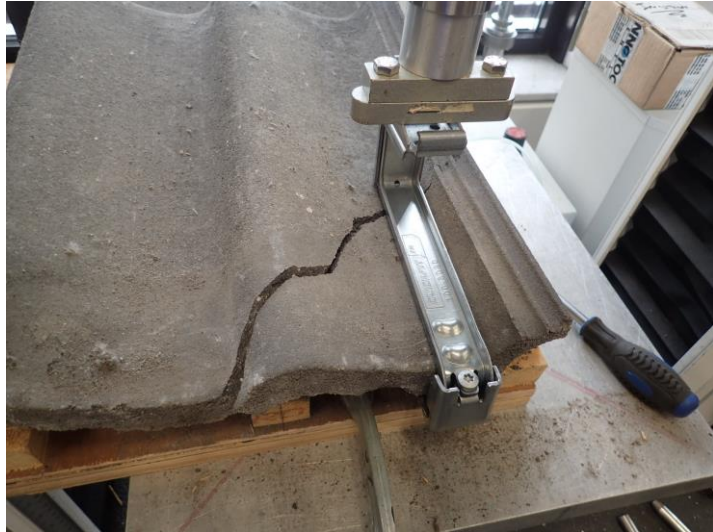
**Photo 11**  
Detail of the collapse  
image.

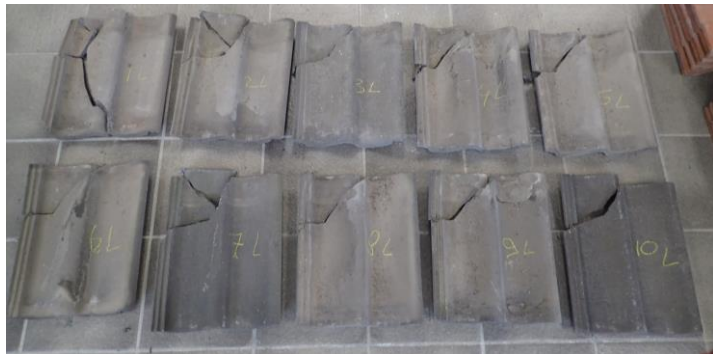
**Photo 12**  
Overview of the collapse  
images.

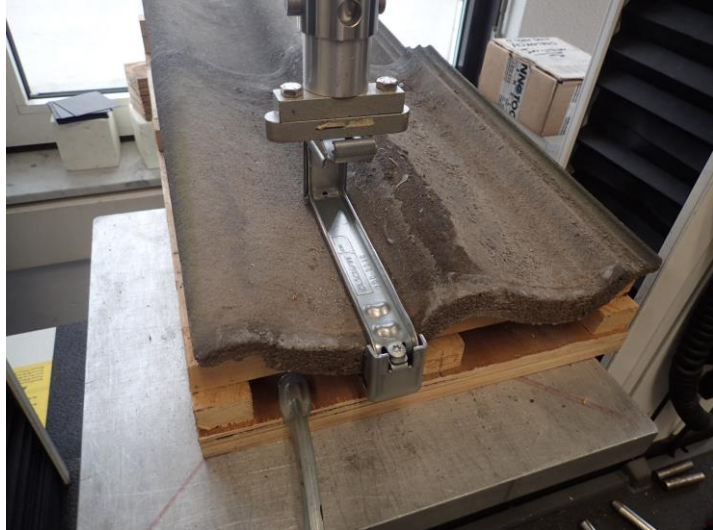
**Photo 13**  
Overview of the test on  
Sneldek RBB (used),  
right valley.

## 2.6 Test 131/3 C2 (ClickFit EVO and Sneldek RBB (used)) right valley

- Substructure : The tile battens, dimensions 25 mm × 38 mm have been placed with a centre to centre spacing of 345 mm and have been fastened to the wooden substructure.
- Tiles : on top of the battens two tiles type Sneldek RBB have been placed.
- Roof hook : on the upper tile one ClickFit EVO roof hook universal have been positioned in the right valley.

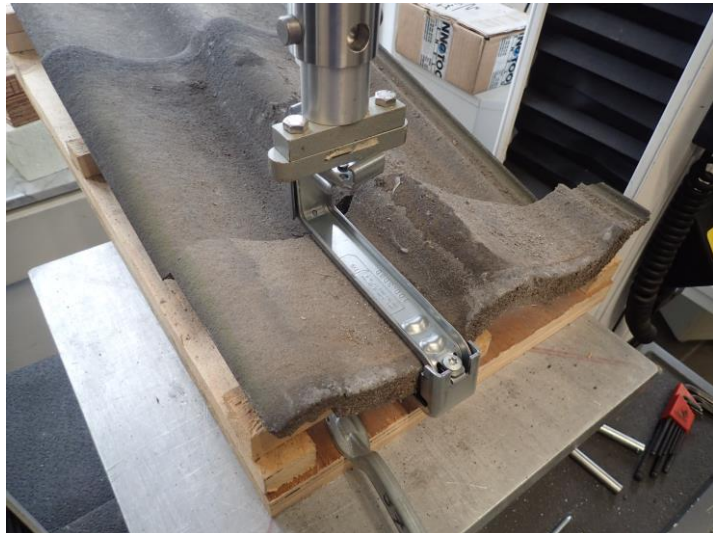
**Photo 14**  
Detail of the collapse  
image.

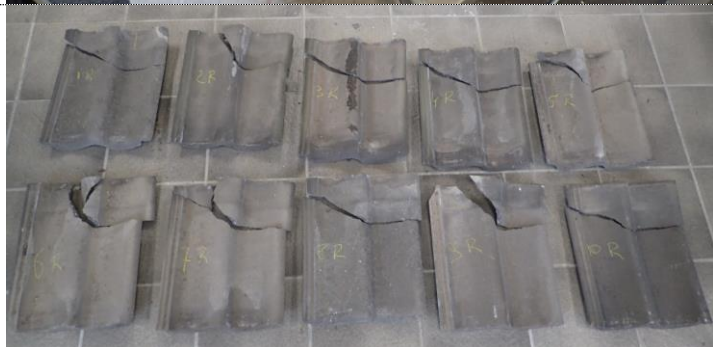
**Photo 15**  
Overview of the collapse  
images.

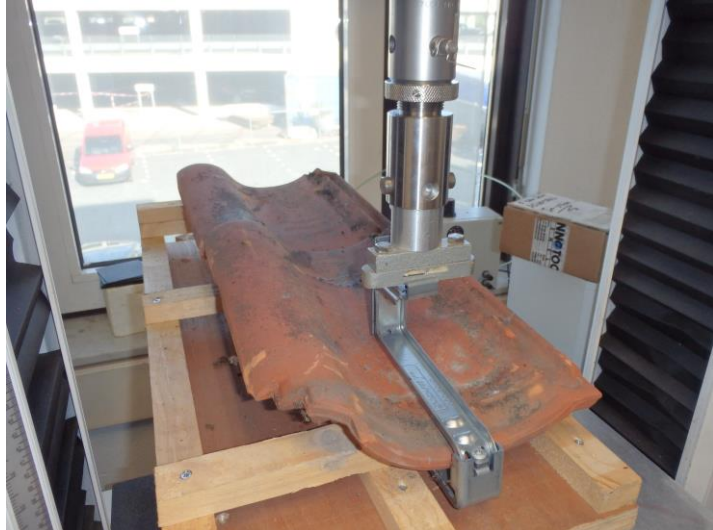
**Photo 16**  
Overview of the test on  
OVH (used).

## 2.7 Test 131/3 D (ClickFit EVO and OVH (used))

- Substructure : The tile battens, dimensions 25 mm × 38 mm have been placed with a centre to centre spacing of 315 mm and have been fastened to the wooden substructure.
- Tiles : on top of the battens two tiles type OVH have been placed.
- Roof hook : on the upper tile one ClickFit EVO roof hook universal have been positioned in the valley.

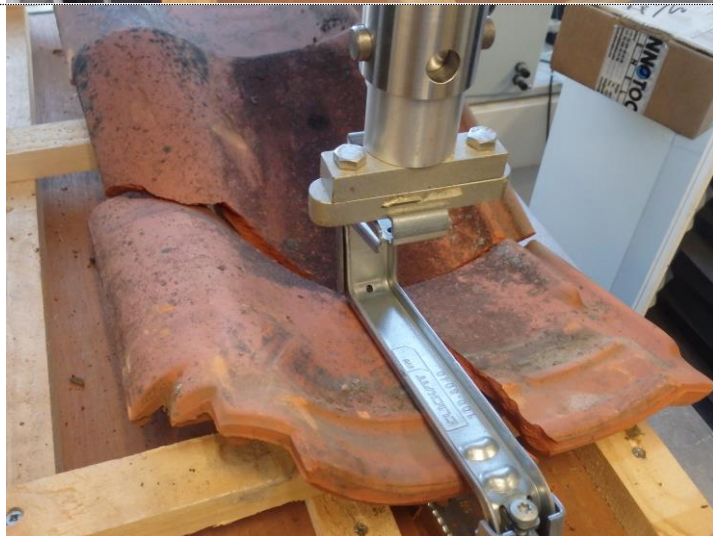
**Photo 17**  
Detail of the collapse  
image.

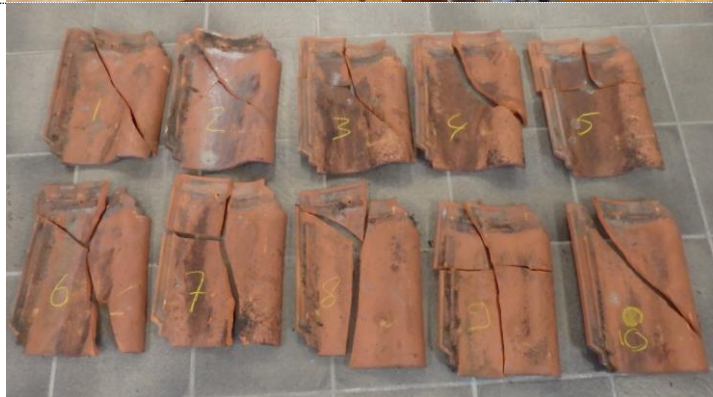
**Photo 18**  
Overview of the collapse  
images.

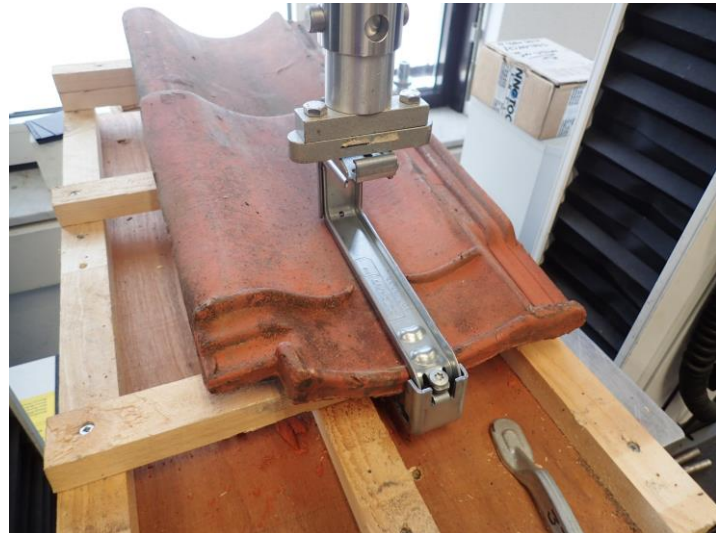
**Photo 19**  
Overview of the test on  
VH-V (used).

## 2.8 Test 131/3 D (ClickFit EVO and VH-V (used))

- Substructure : The tile battens, dimensions 25 mm × 38 mm have been placed with a centre to centre spacing of 280 mm and have been fastened to the wooden substructure.
- Tiles : on top of the battens two tiles type VH-V have been placed.
- Roof hook : on the upper tile one ClickFit EVO roof hook universal have been positioned in the valley.

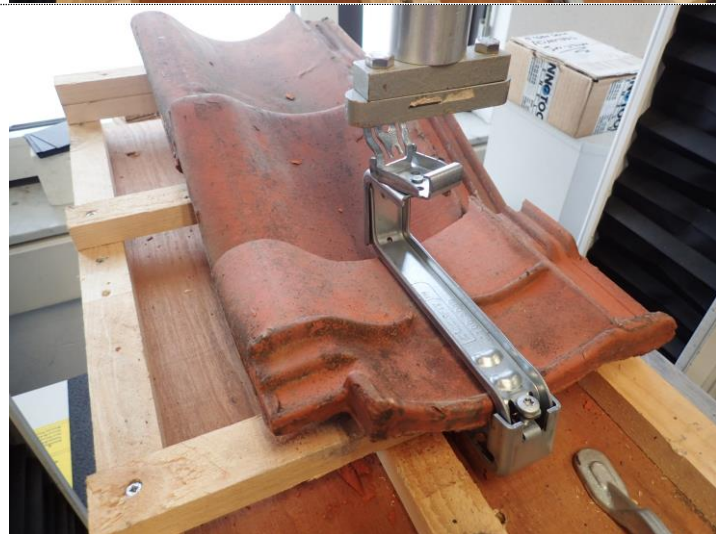
**Photo 20**  
Detail of the collapse  
image.

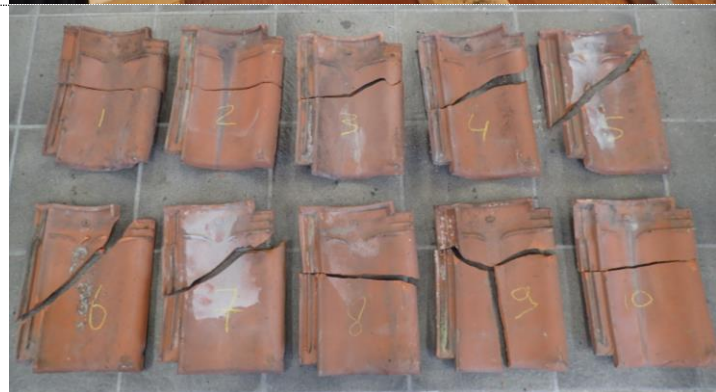
**Photo 21**  
Overview of the collapse  
images.
